Project Summary:

New Hope-Solebury School District High School Modernization Study

21 April, 2014

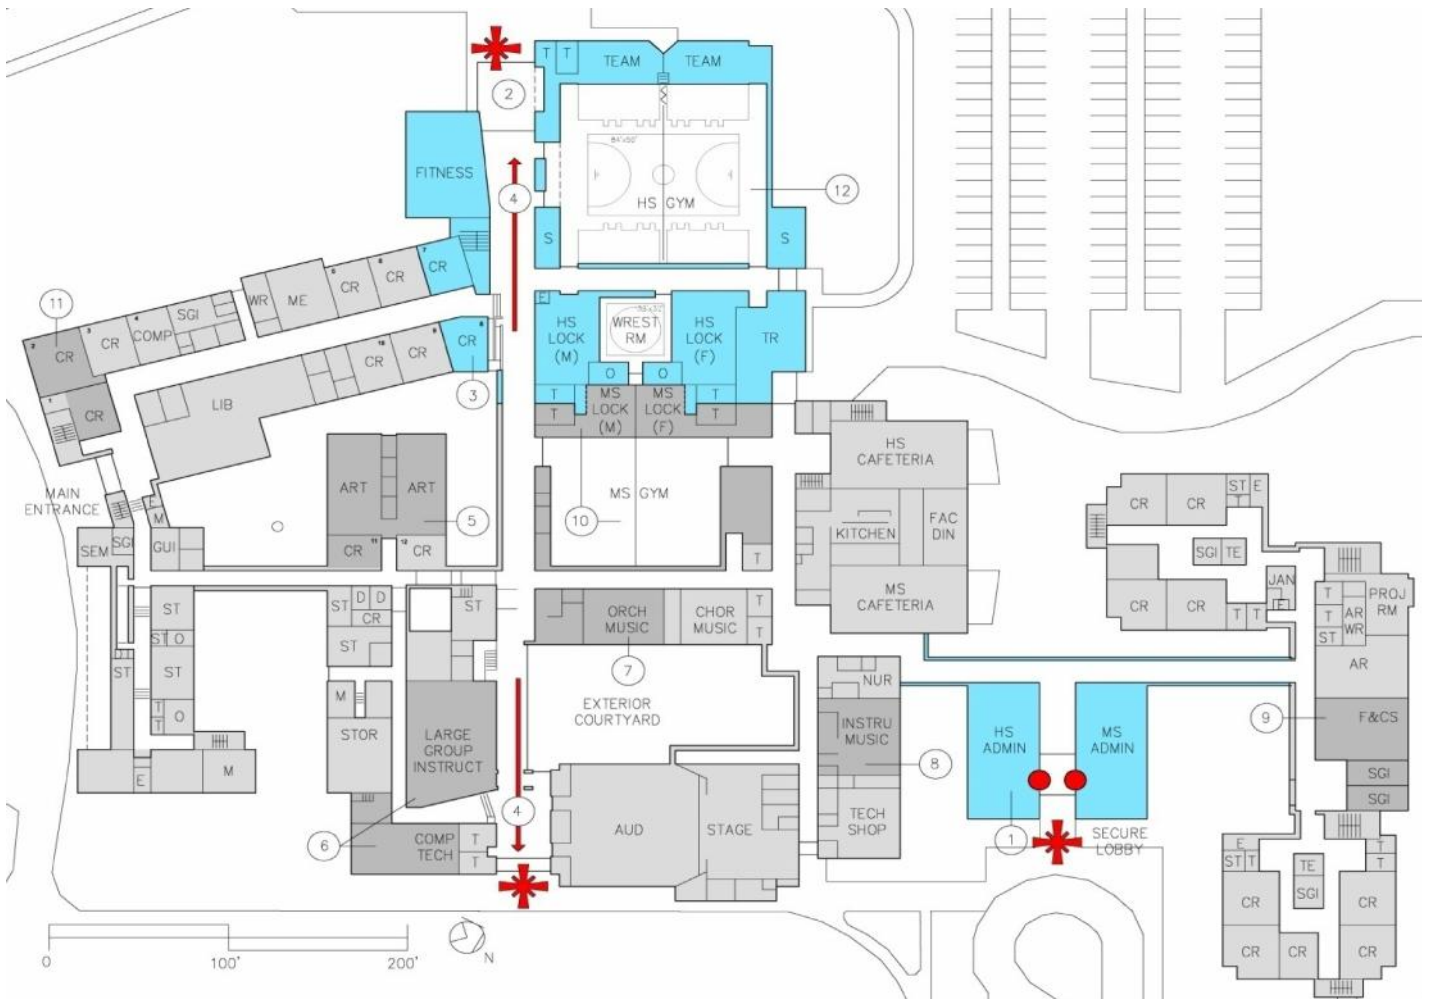
- 8 Renovate for Orchestra Room.
- 9 Renovate former MS Admin for Family and Consumer Science.
- 10 Existing HS Gym utilized for MS.
- 11 Renovate former HS Admin for additional HS classrooms

- 12 New HS / Public Athletic Center.
- 13 New Senior Lounge constructed within Courtyard.

Estimated Project Cost - \$30-35 million

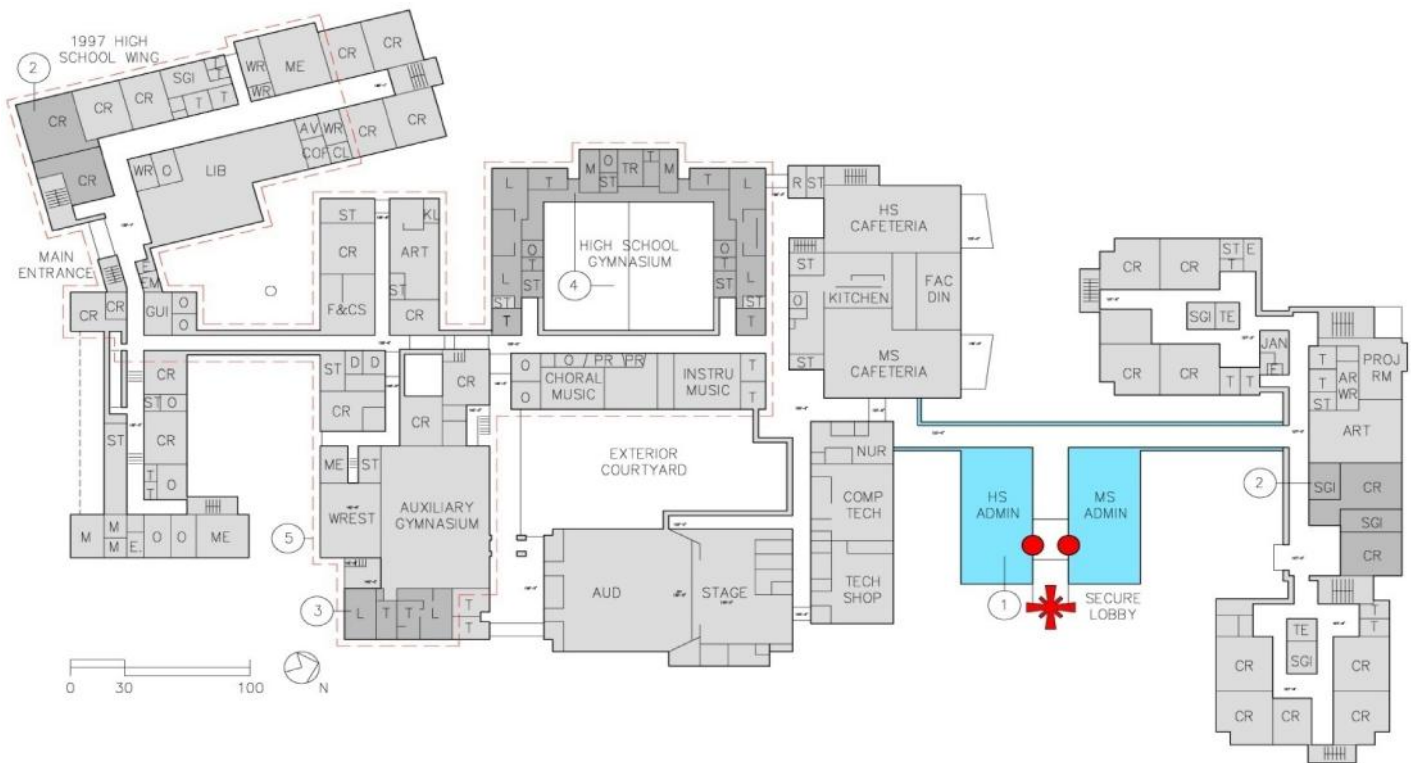
High School Design Option 3 Lower Level

- 1 New Public Entrance and centralized HS & MS Administration. Addition links two buildings together to eliminate the need for exterior circulation.
- 2 Renovate former HS & MS Admin for additional Classroom Space.
- 3 MS Gymnasium stays in its current location. Renovate existing MS Locker Rooms for improved visibility and condition.
- 4 HS Gymnasium stays in its current location. Renovate existing HS Gym and Locker Rooms for improved condition.
- 5 Renovate 1930-60s construction for infrastructure improvement

Estimated Project Cost - \$14-15 million
